Mechanical Refurbish Ford 302 Volvo AQ

1968 Donzi Bench Seat Hornet Hull 38:

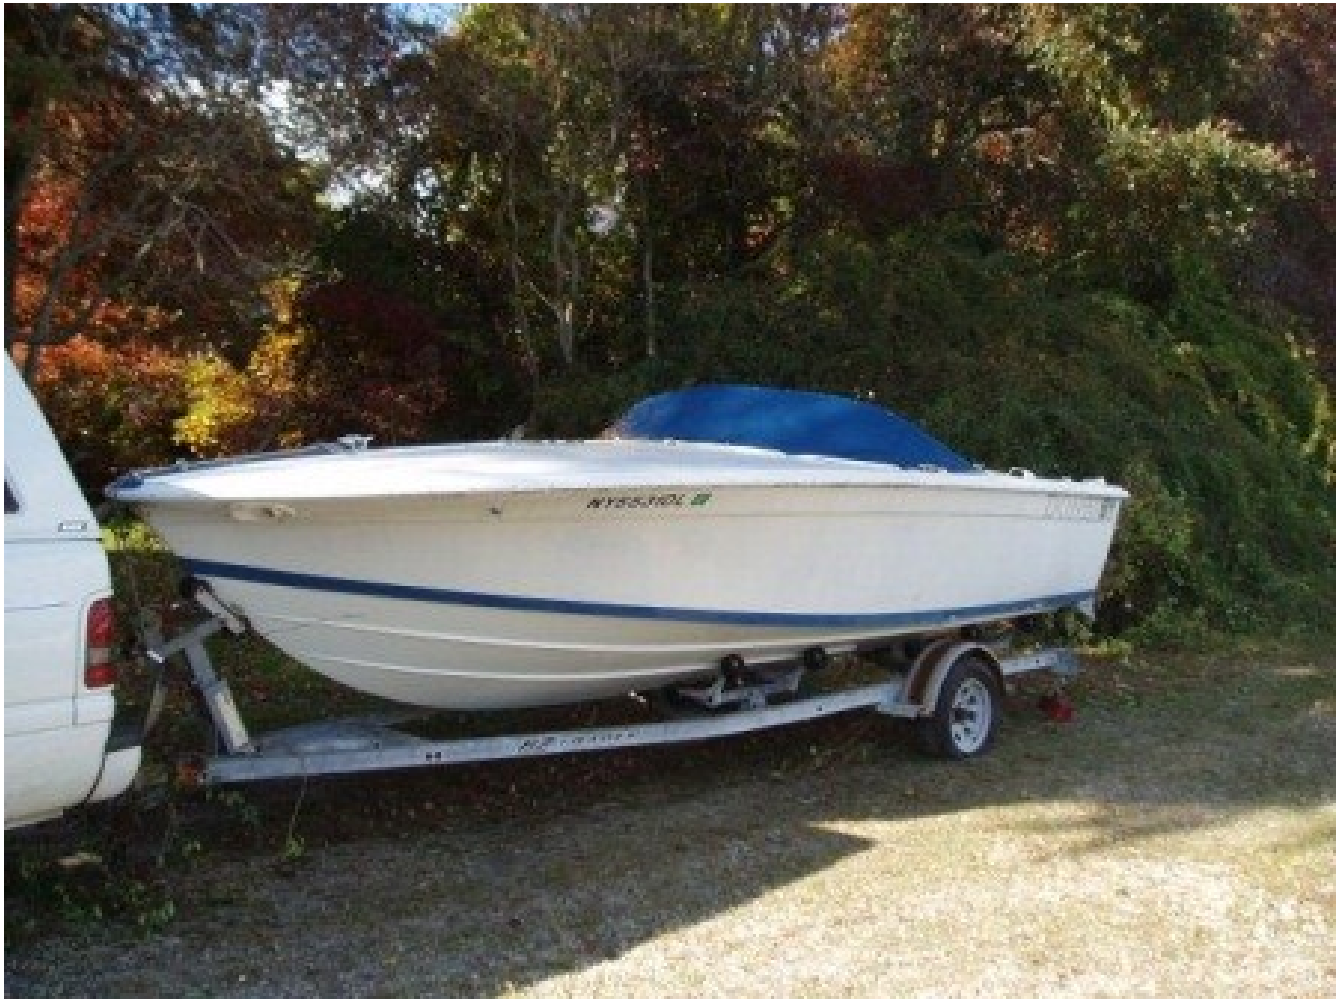
The boat was found out on Long Island NY and was in very good structural shape but the wiring and mechanicals had succumbed to 40 years in the salt water environment. The drivetrain and rigging were removed and refurbished. Here is a detail of the work done.

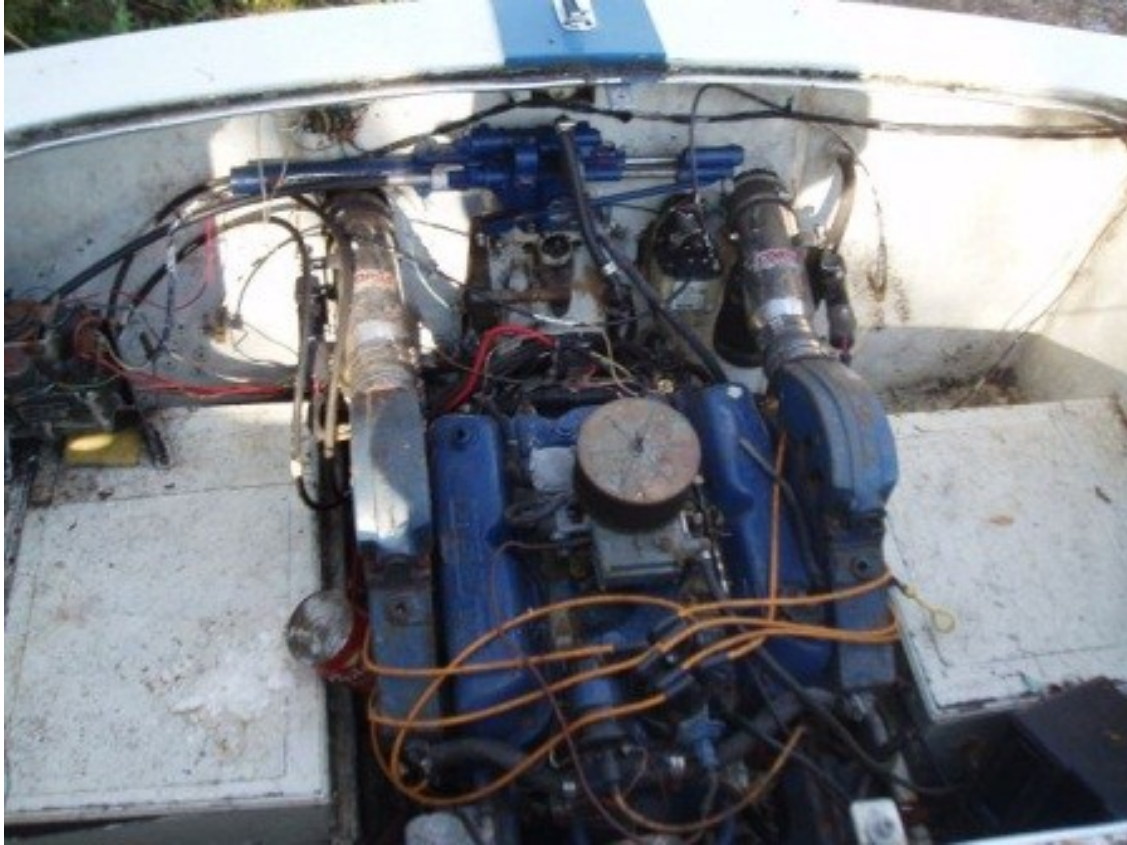
The boat was trailer stored but still had a fair amount of corrosion from being stored next to the bay. The original 225hp 1968 289 Holman Moody Ford motor was replaced sometime over its life with a 1987 225hp Ford 5.0. The boat was fitted with a Corsa switchable exhaust and Volvo power steering.

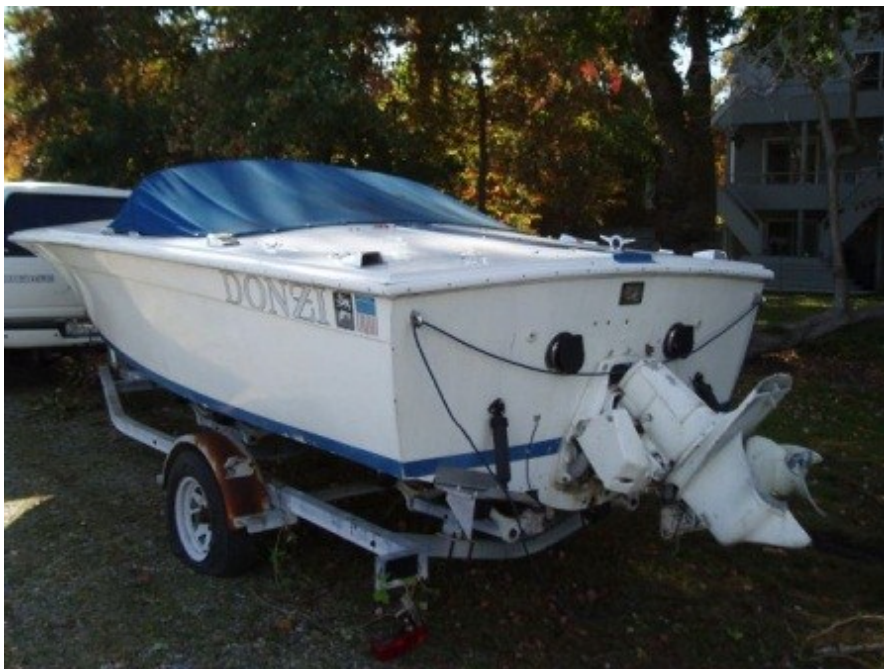
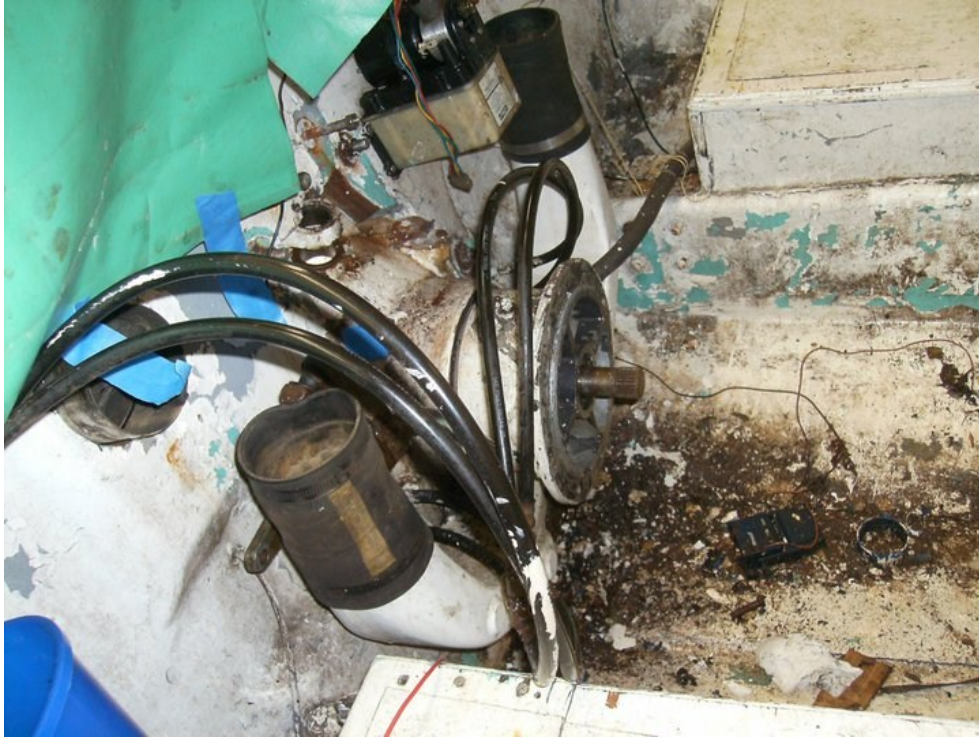
The wiring and the rigging were in sad shape so the mechanicals were removed from the boat for a refurbish. The drive was removed; the transom was tested and inspected. It was in excellent shape for a boat of this vintage.

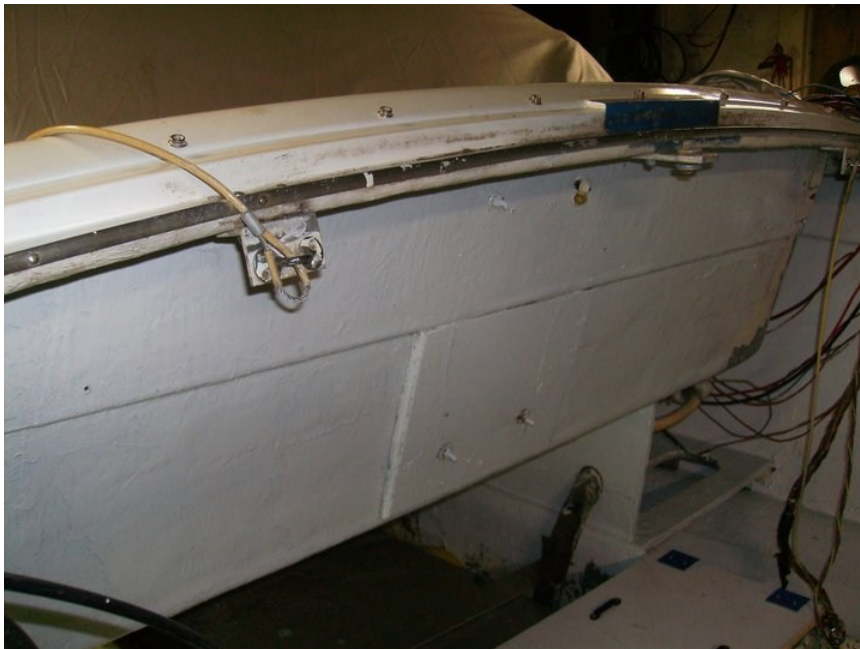
The bilge ready for painting. White PPG paint was used it was rolled and tipped.

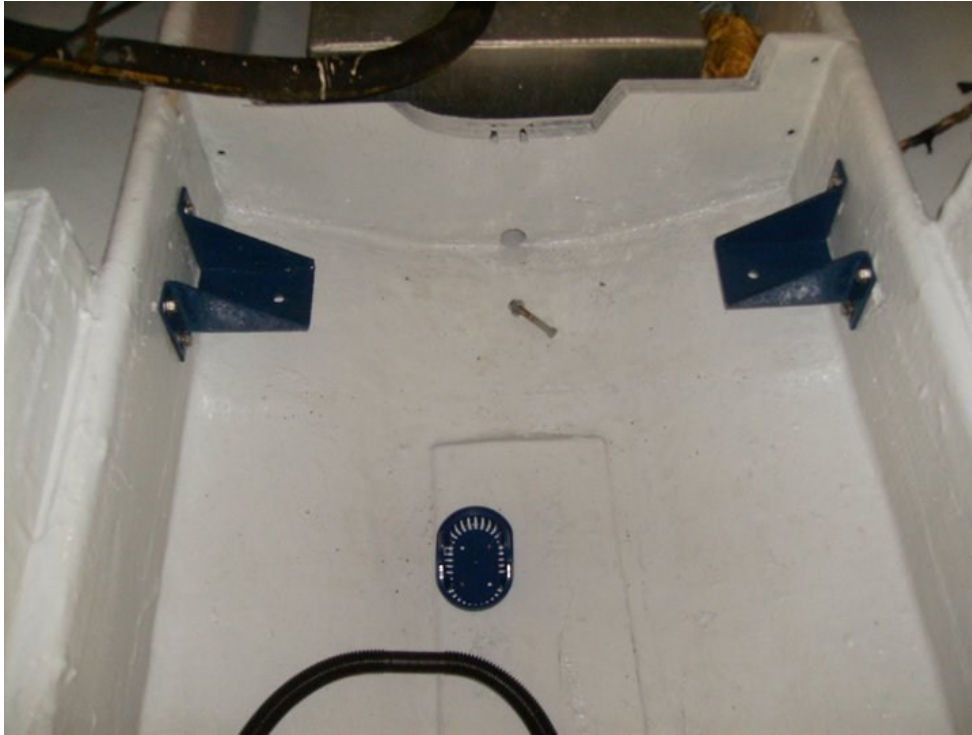
The same angle as the previous picture with one coat of paint.

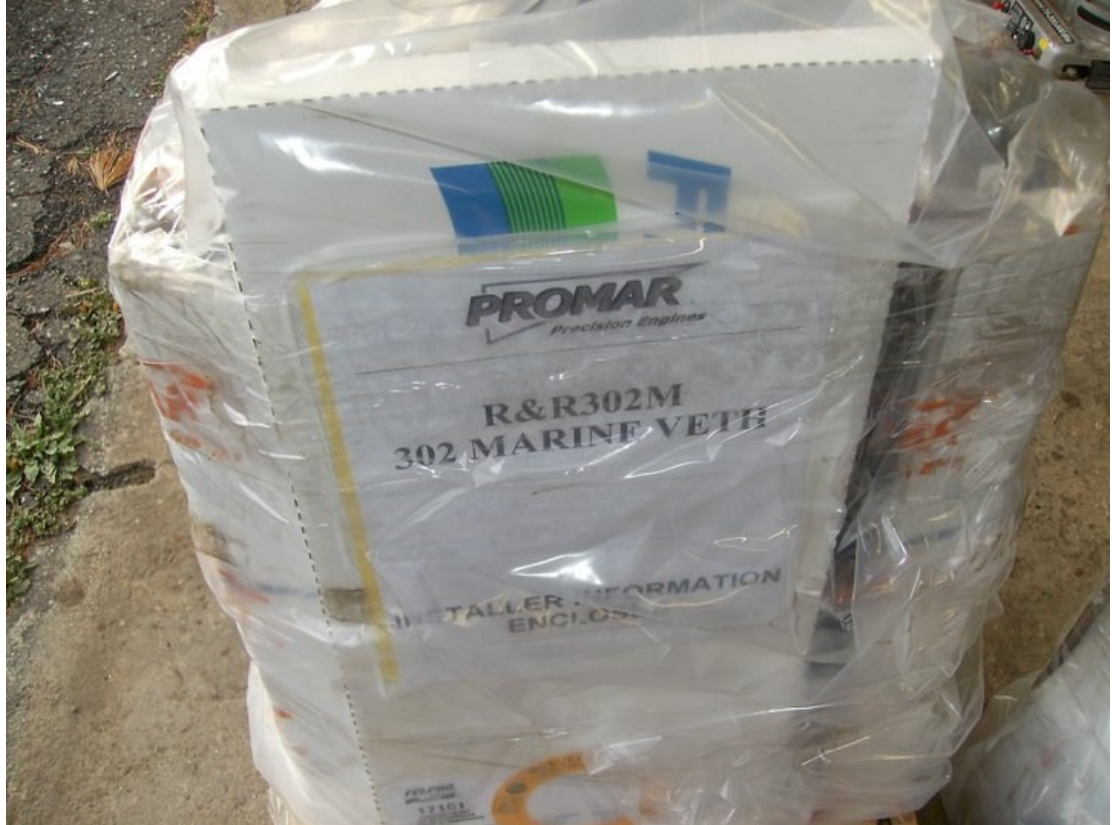
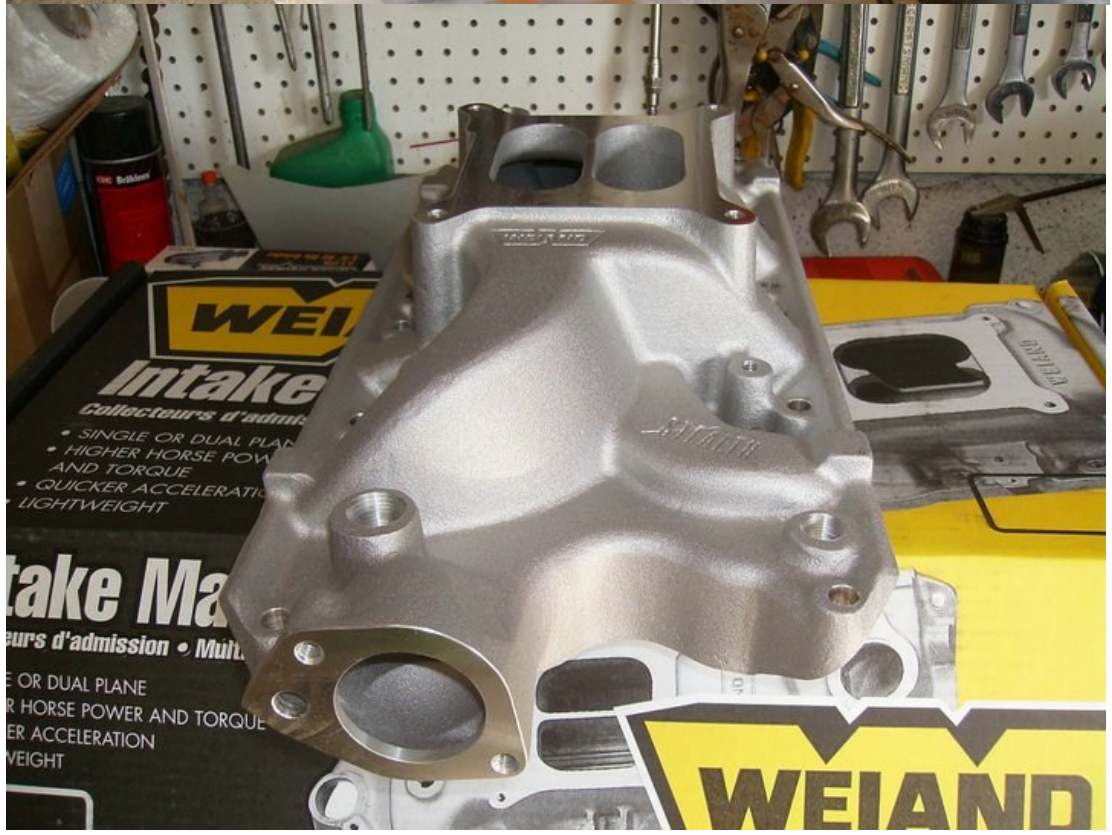
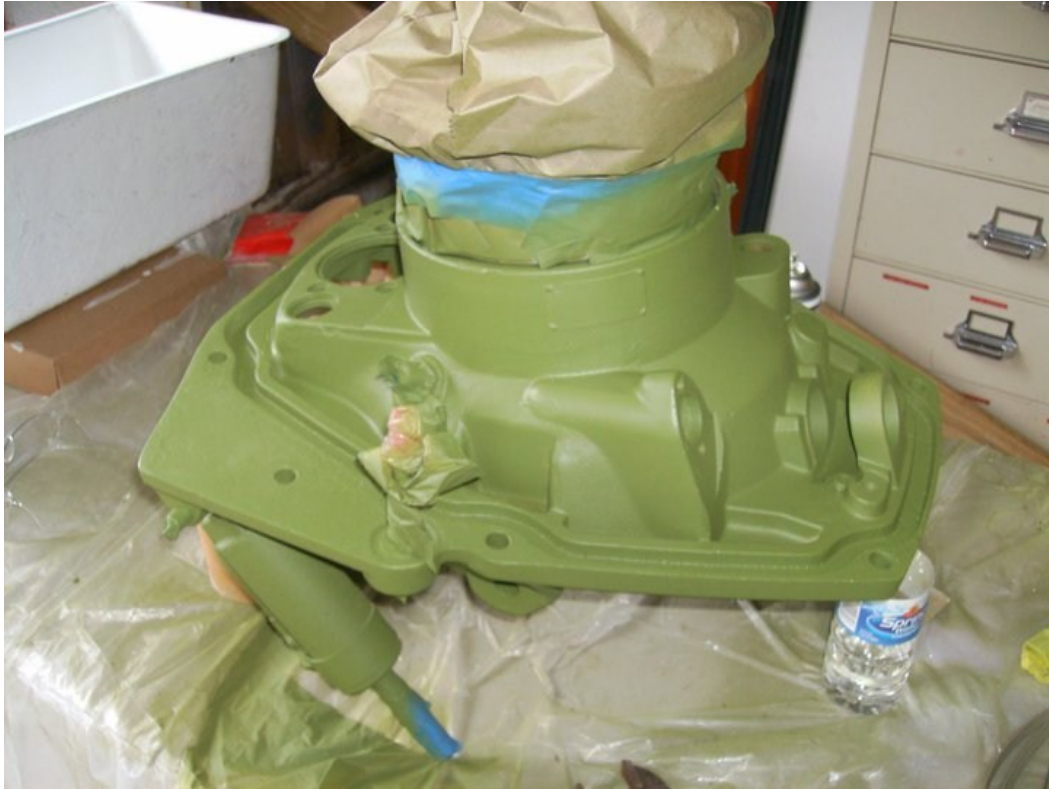
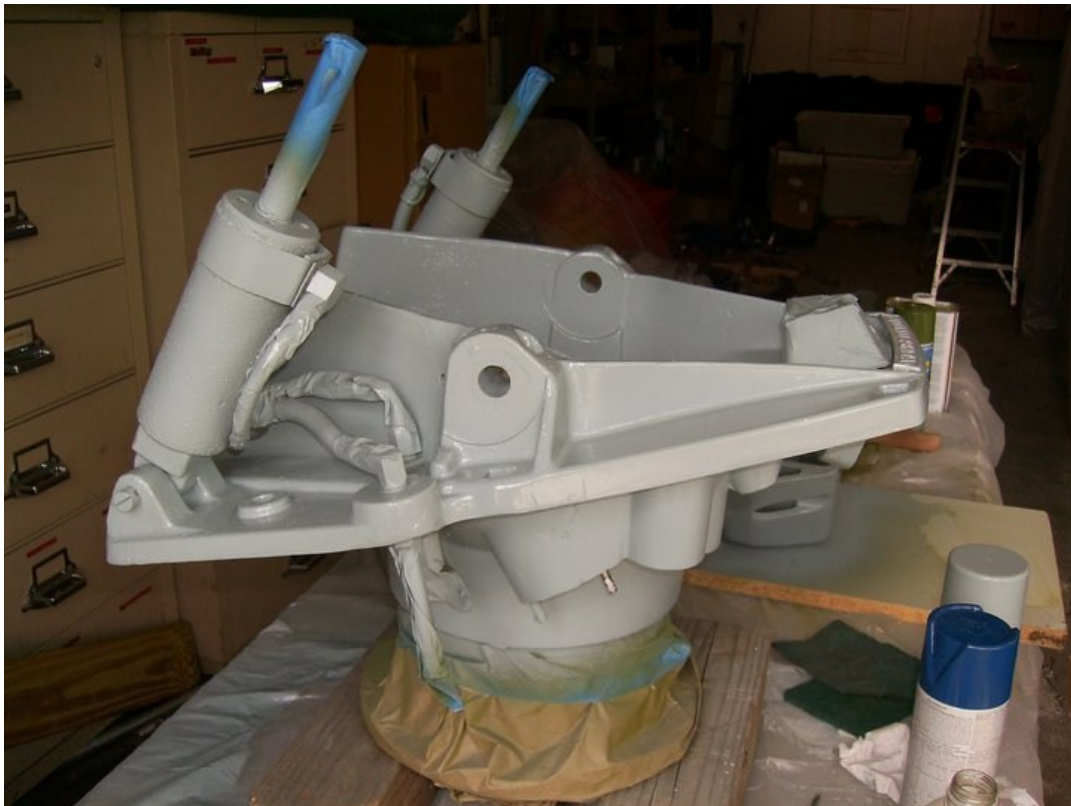
The bilge after painting. The motor mounts and all of the motor parts were painted with Por 15 Ford Blue paint. It holds up well and is rust inhibitor paint. With the bilge finished it was now time to turn to the mechanicals.

The other parts of the motor were cleaned, prepped and painted.

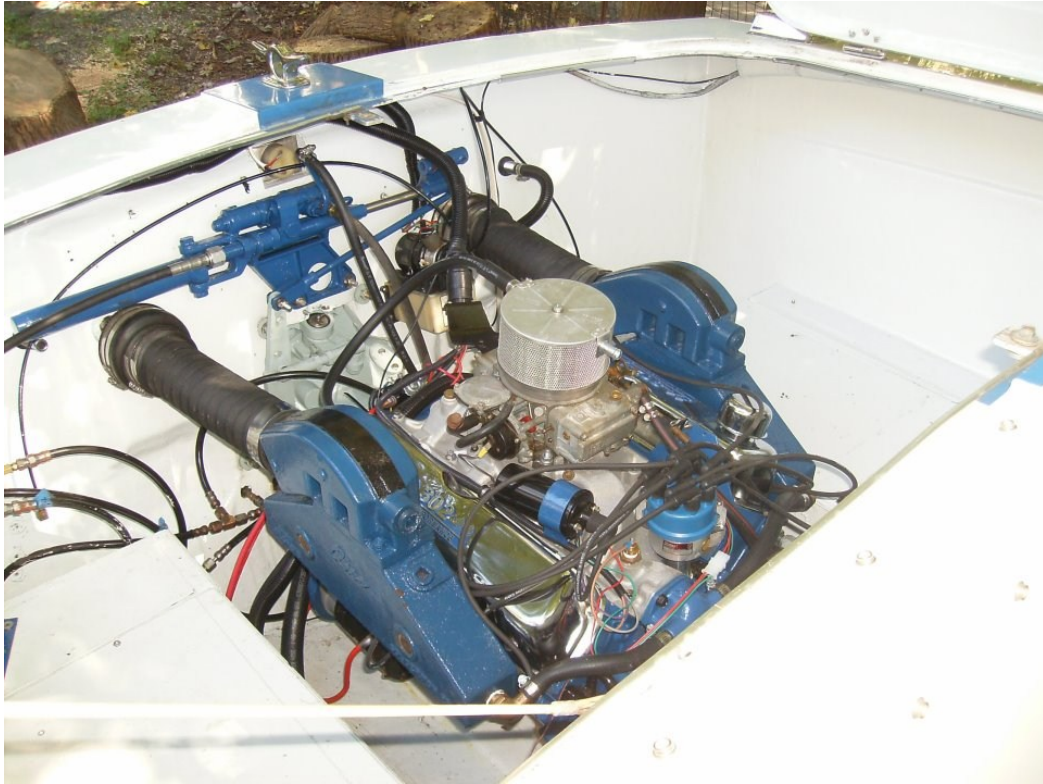
The motor was assembled and painted waiting installation.

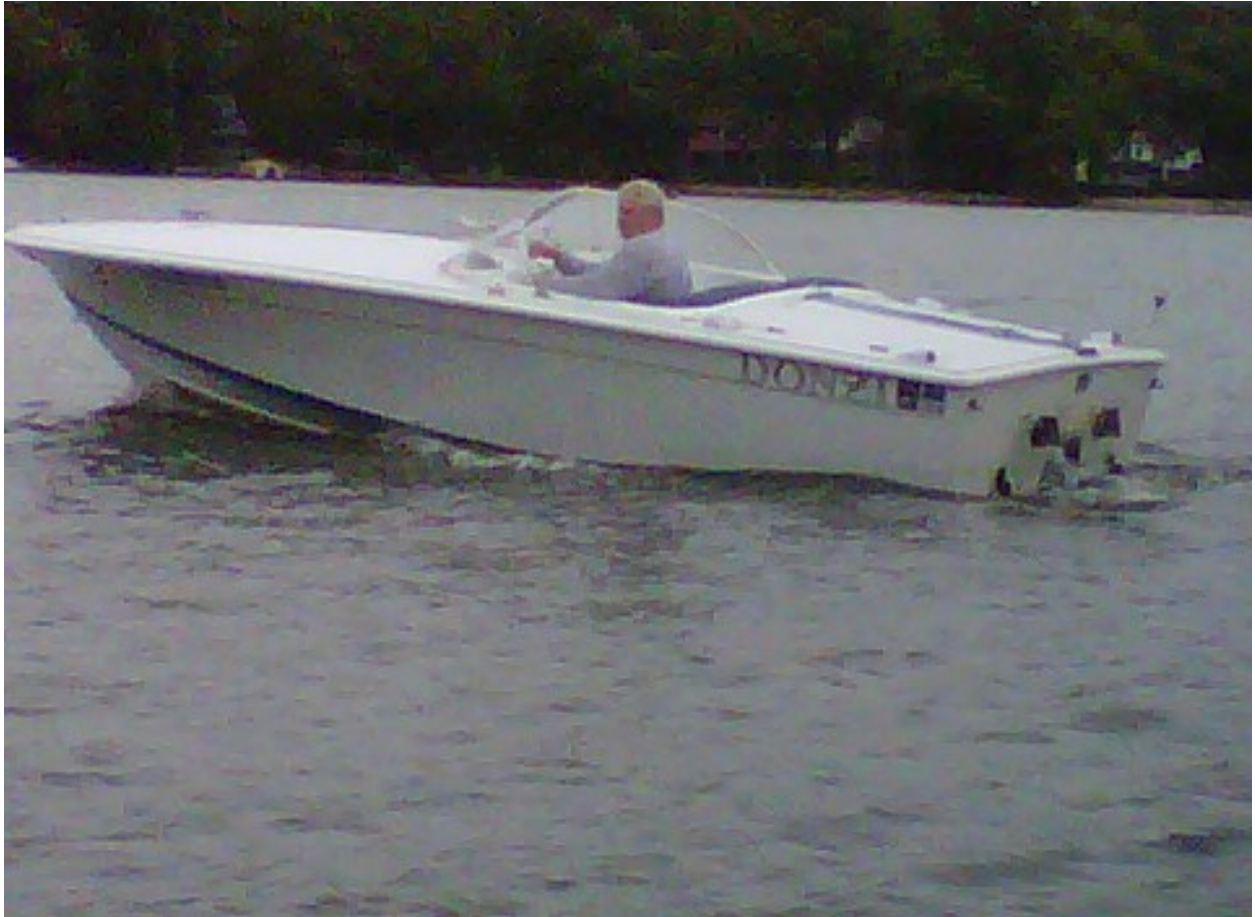
Motor and drive installed.
